SUBJ: EPA Asbestos Removal at 403 Potts Street (community garden)

REMOVAL ACTION STATUS REPORT DAVIDSON ASBESTOS

Property Address: 403 Potts Street, Davidson, Mecklenburg County, North Carolina

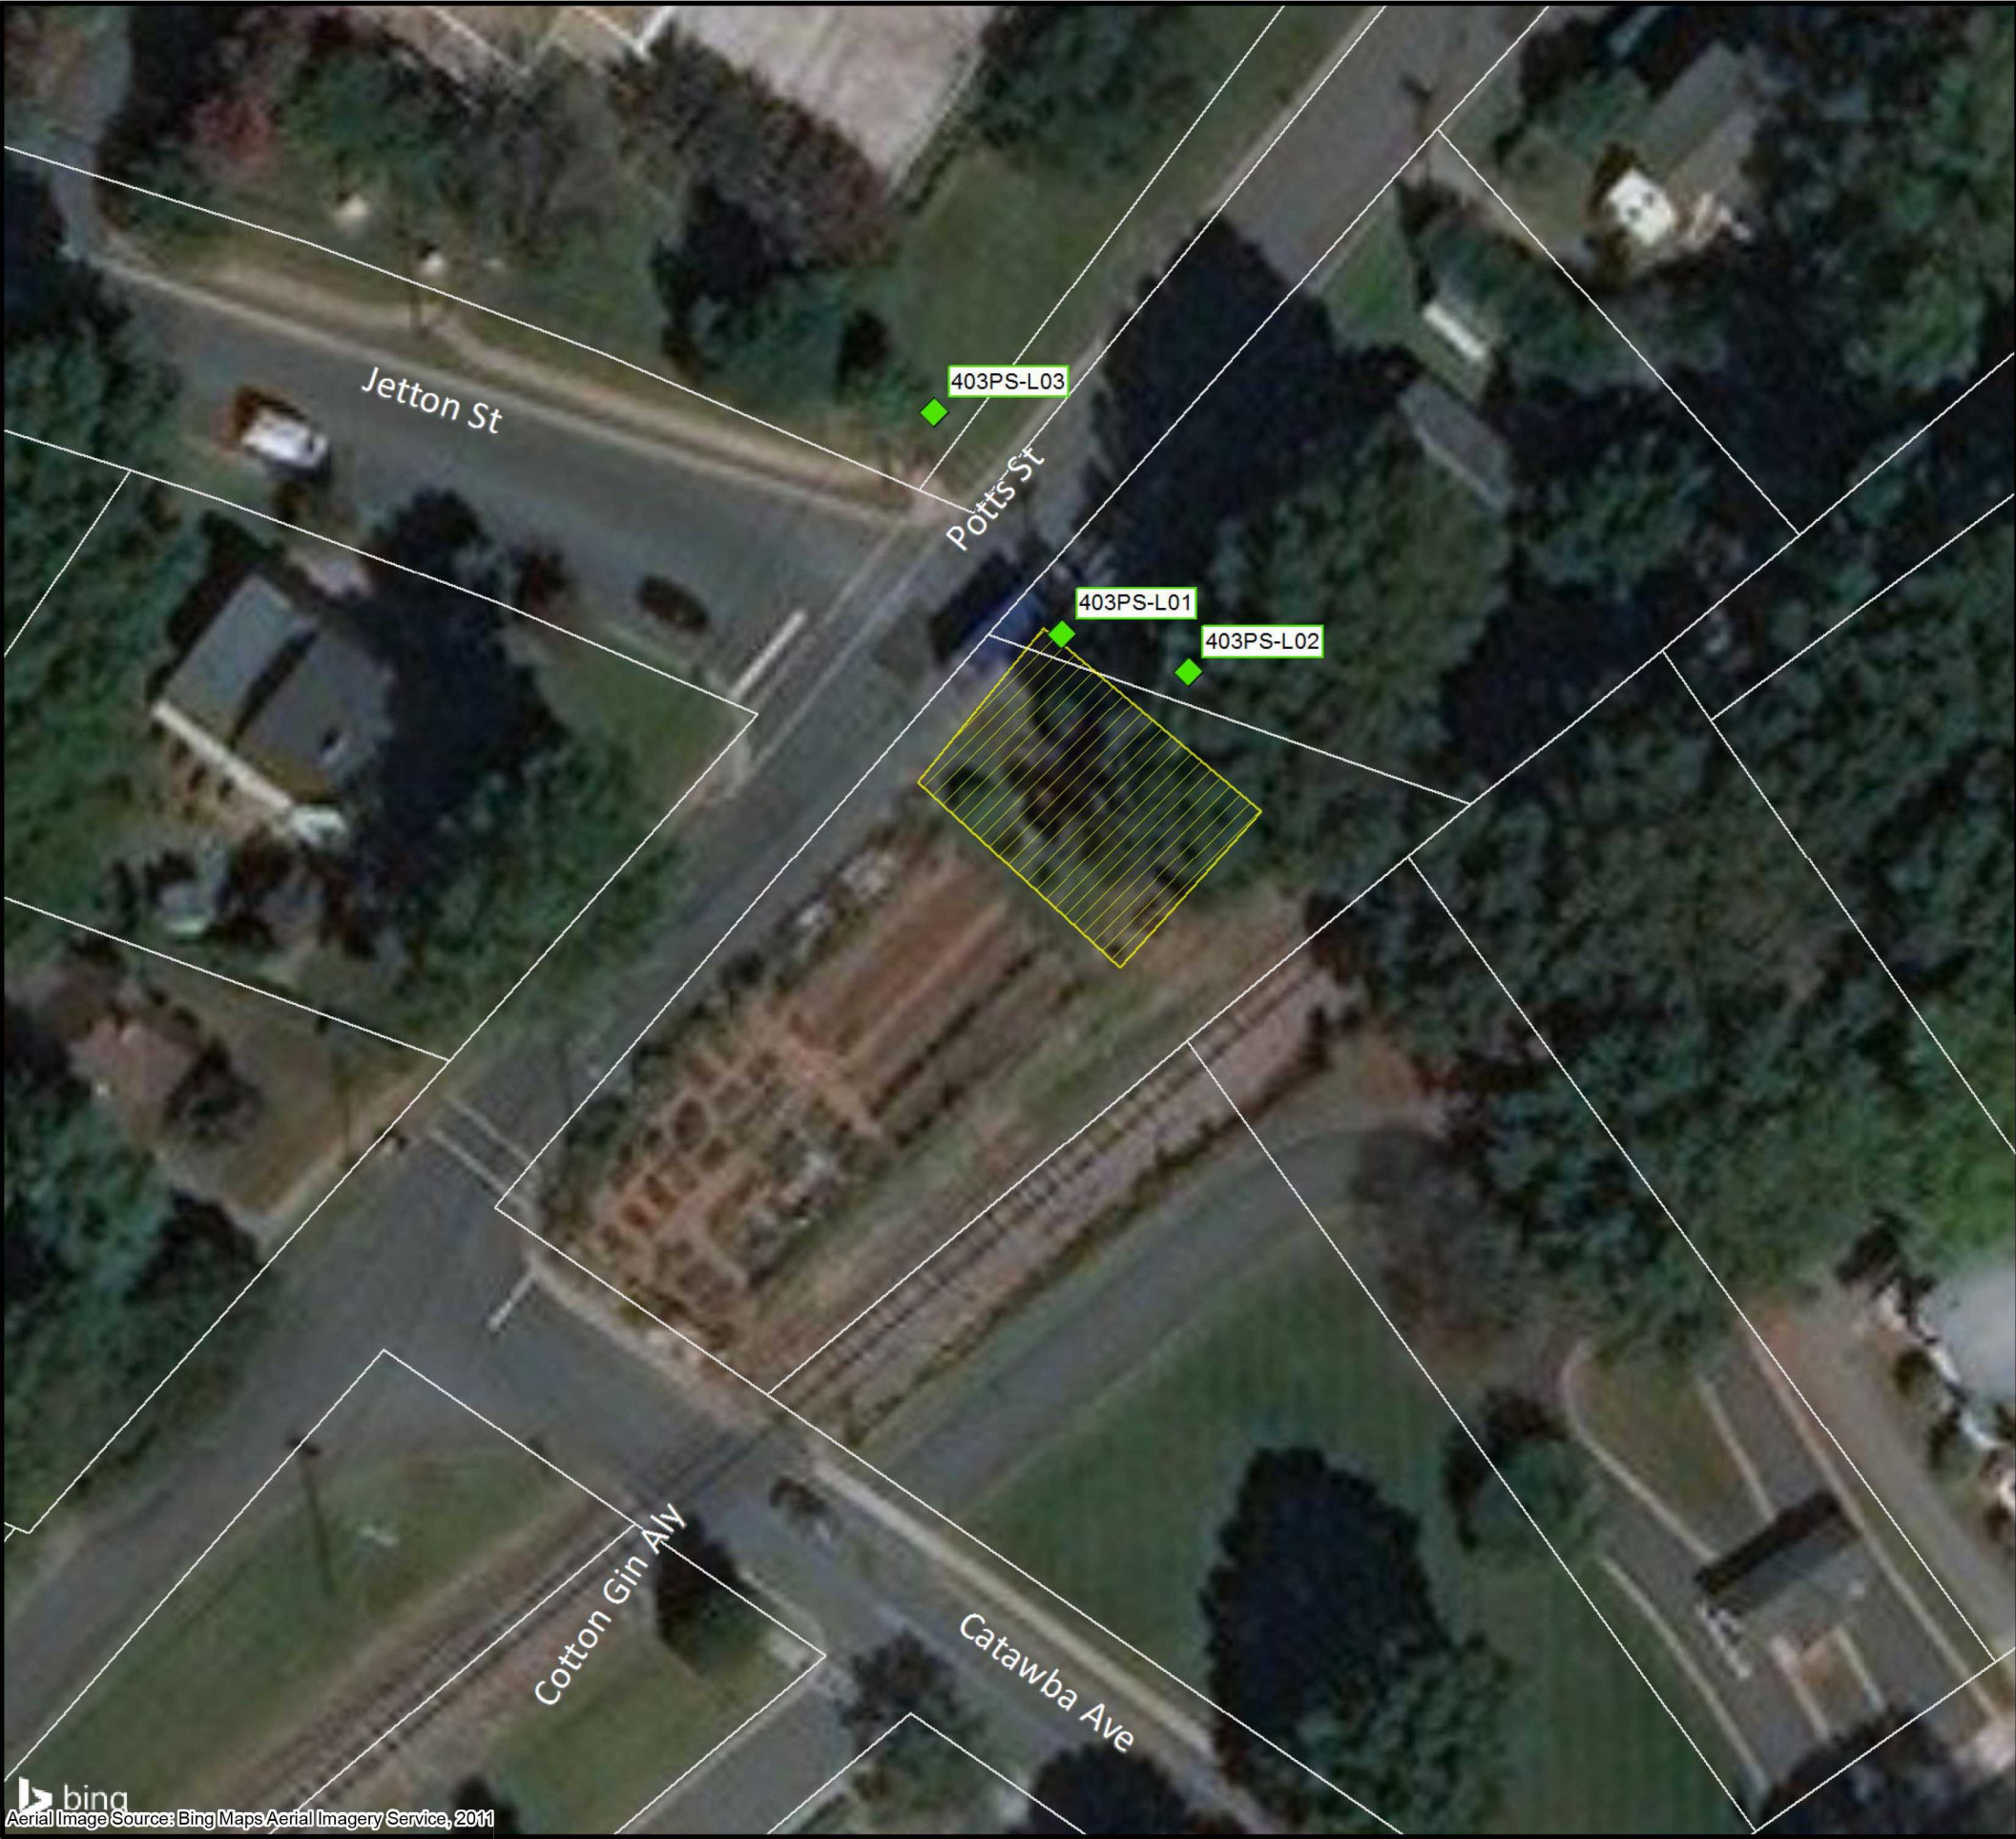
FIGURE 1

Description of Removal Action: The soil was excavated to an approximate maximum depth in the following areas: lawn to 12 inches and tree and shrub line areas to 3 inches (see Appendix 1).

**Removal Areas and
Air Sampling Locations**

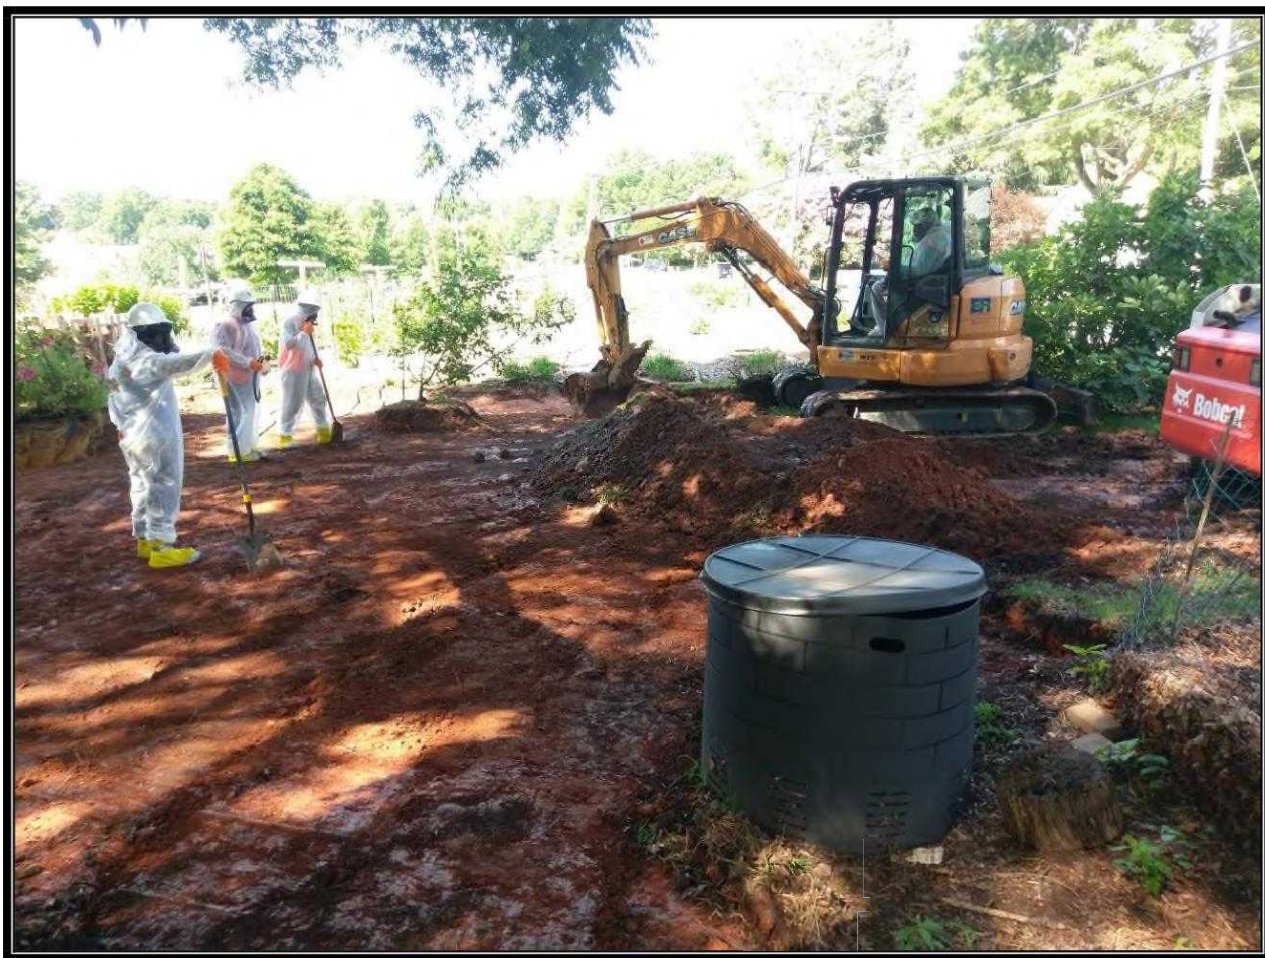
OFFICIAL PHOTOGRAPH NO. 1
U.S. ENVIRONMENTAL PROTECTION AGENCY

Subject: The Emergency and Rapid Response Services (ERRS) contractor, Environmental Restoration, LLC (ER), used an excavator and hand tools to remove asbestos-containing materials (ACM) and asbestos-contaminated soil from the property located at 403 Potts Street. ER used hoses to wet the asbestos-contaminated soil during removal activities.

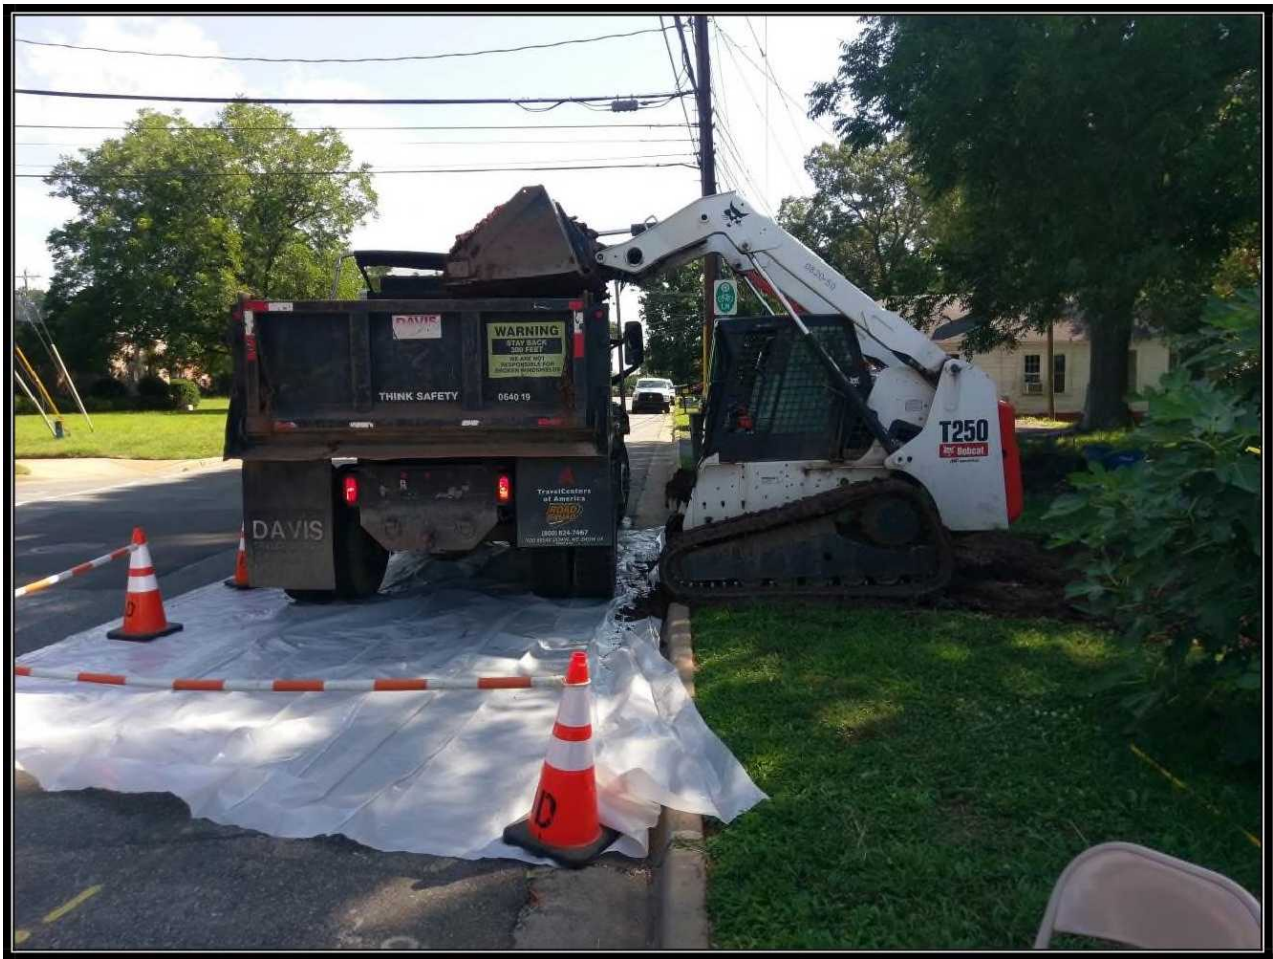
OFFICIAL PHOTOGRAPH NO. 2
U.S. ENVIRONMENTAL PROTECTION AGENCY

Subject: ER used a skid steer and dump trucks to load and transport the asbestos-contaminated soil from the property to the staging area located at 206 Watson Street for disposal. ER placed plastic sheeting under the dump trucks to prevent asbestos-contaminated soil from falling onto the road during removal activities.

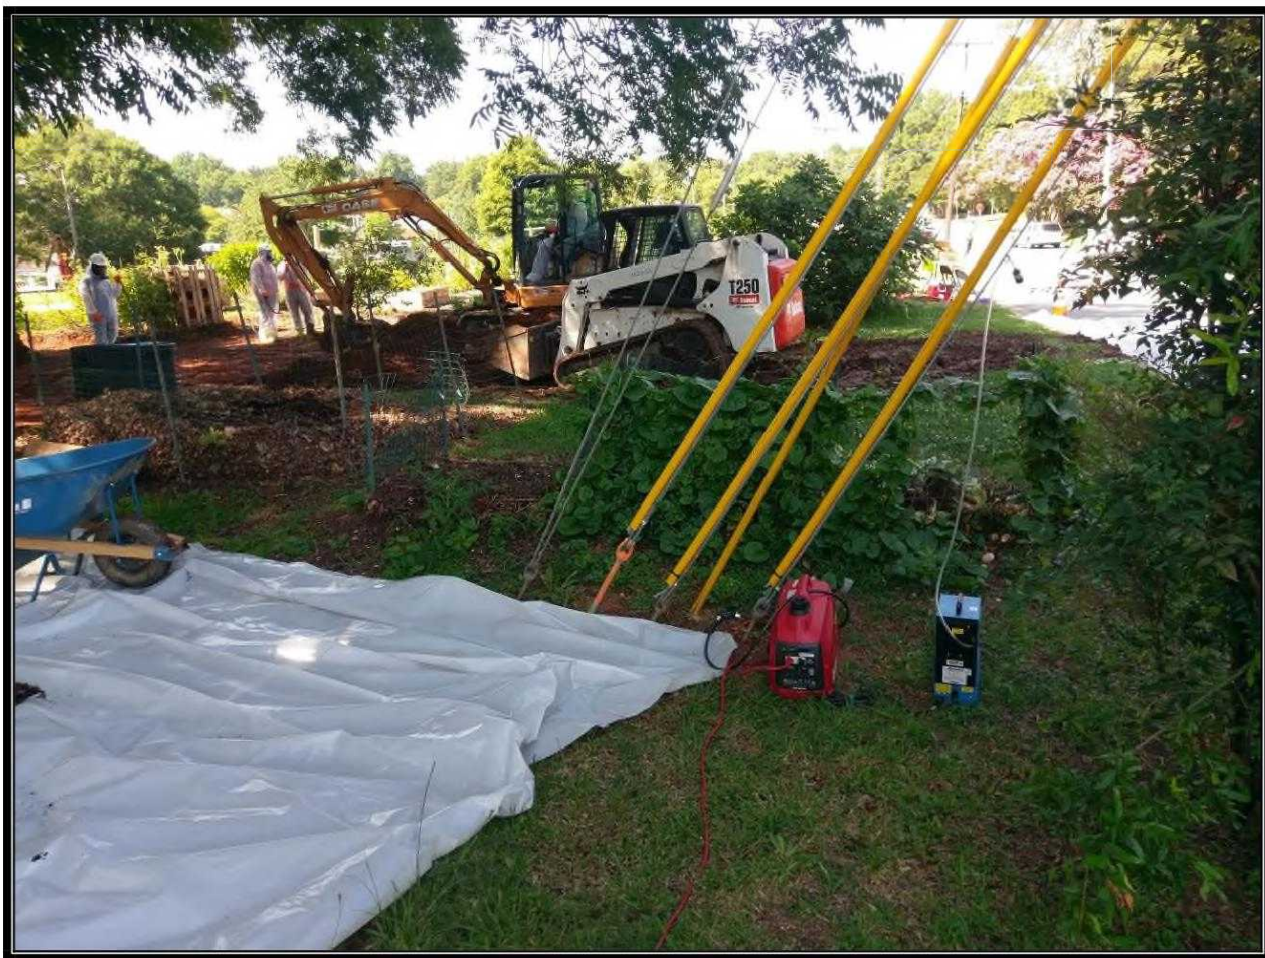
OFFICIAL PHOTOGRAPH NO. 3
U.S. ENVIRONMENTAL PROTECTION AGENCY

Subject: Perimeter air sampling was conducted by a Tetra Tech Superfund Technical and Response Team (START), State of North Carolina-accredited air monitor, to evaluate the effectiveness of engineering and safety controls in preventing the off-site migration of asbestos fibers during removal activities.

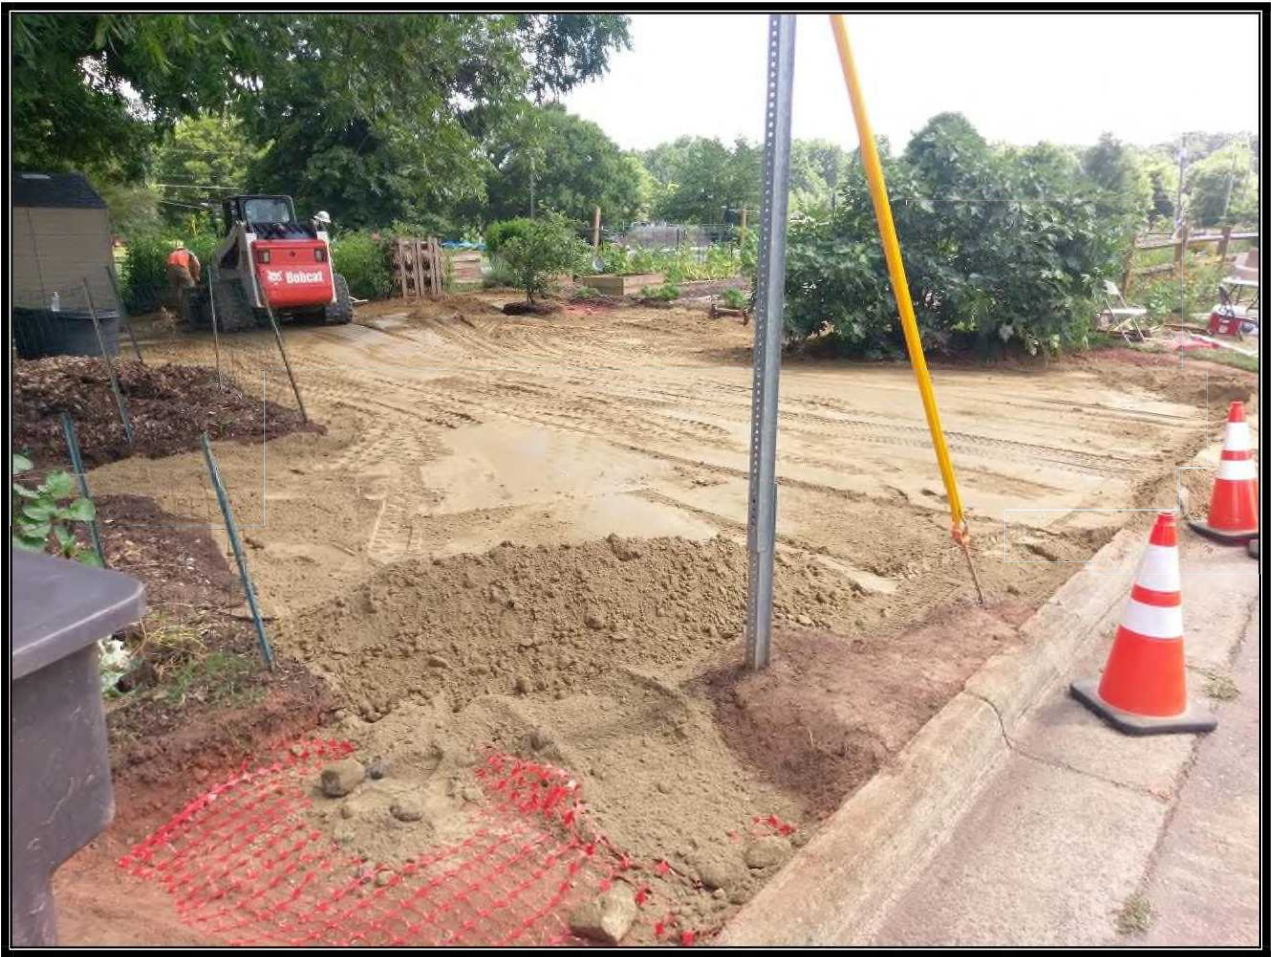
OFFICIAL PHOTOGRAPH NO. 4
U.S. ENVIRONMENTAL PROTECTION AGENCY

Subject: ER installed snow fencing along and backfill over the subsurface of the excavated area after the visual inspection conducted by Tetra Tech START, State of North Carolina-accredited asbestos inspector and air monitor, detected no visible ACM in the excavated area.

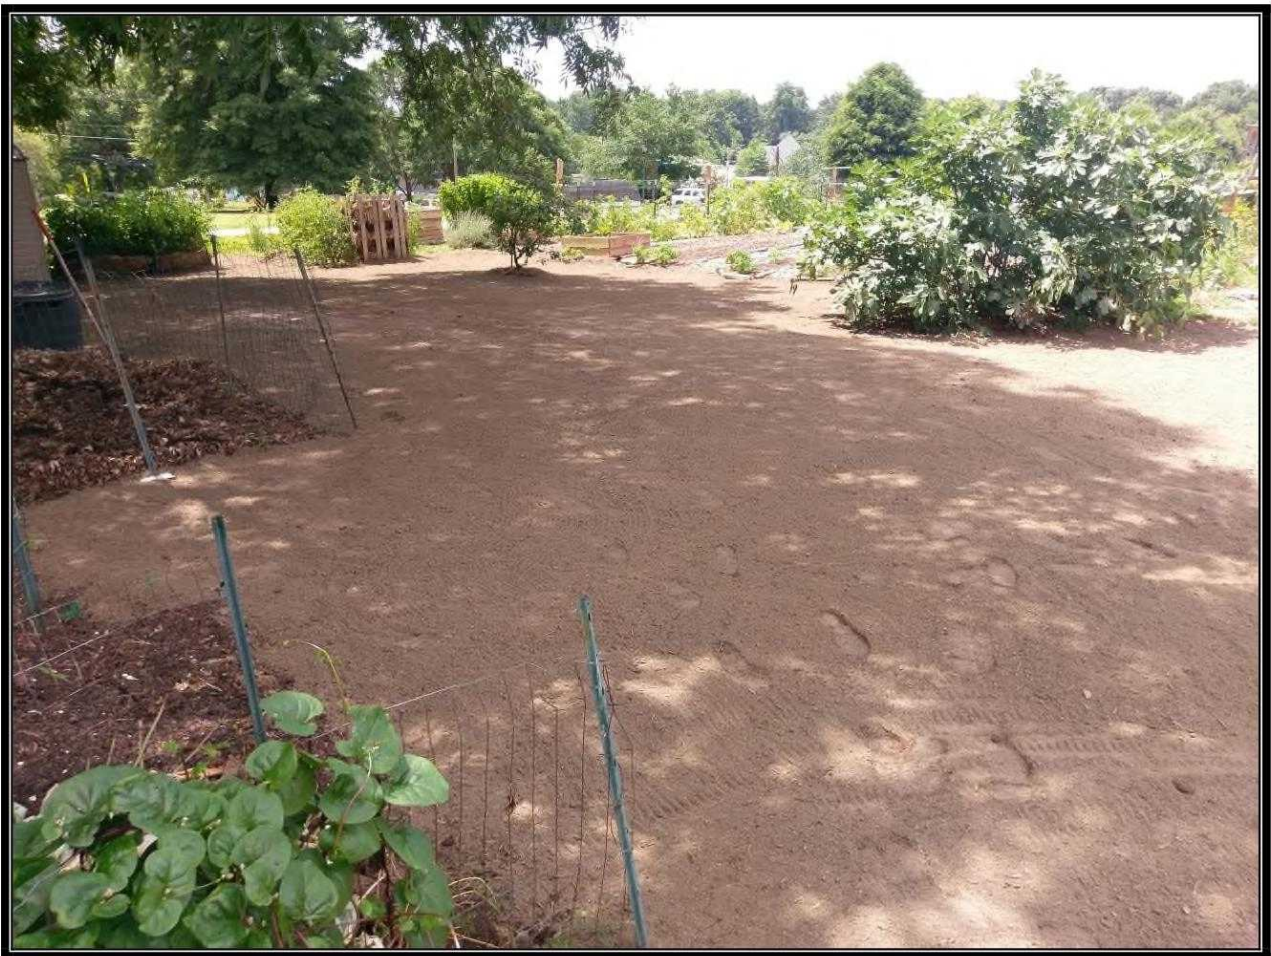
OFFICIAL PHOTOGRAPH NO. 5
U.S. ENVIRONMENTAL PROTECTION AGENCY

TDD Number:	TT-01-071	Location:	Davidson Asbestos
Orientation:	South	Date:	July 7, 2017
Photographer:	Paul Prys, Tetra Tech	Witness:	None
Subject:	ER used dump trucks, skid steers, and rakes to install topsoil in the excavated areas.

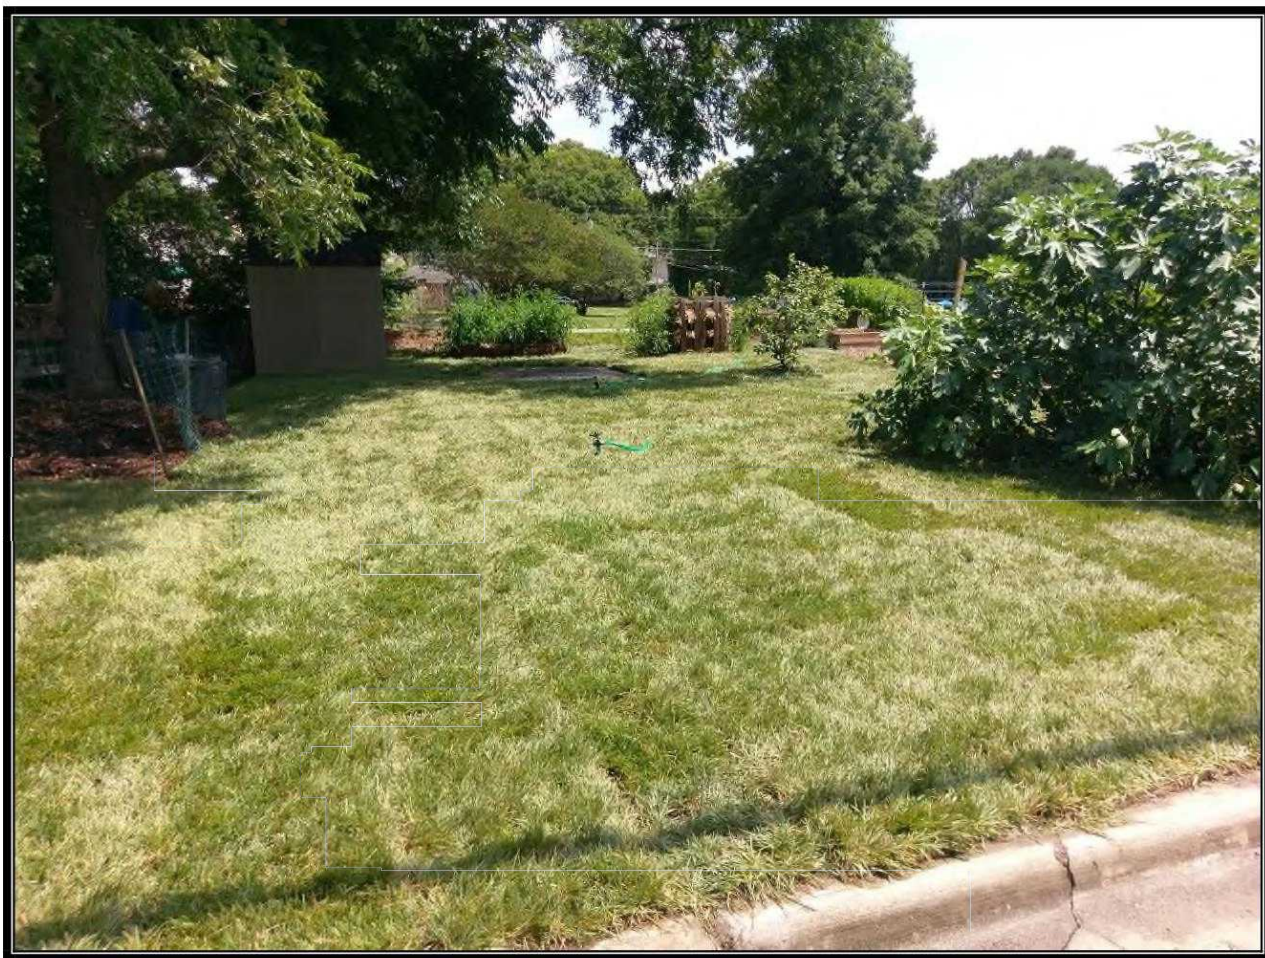
OFFICIAL PHOTOGRAPH NO. 6
U.S. ENVIRONMENTAL PROTECTION AGENCY

Subject: ER installed sod in the excavated areas after backfill and topsoil were in place. ER used hoses with sprinkler attachments to water the sod.
